Mission Success for the Planetary Exploration Spacecraft

NEC Corporation

Asteroid Explorer “Hayabusa”

“HAYABUSA” survived seven challenges!

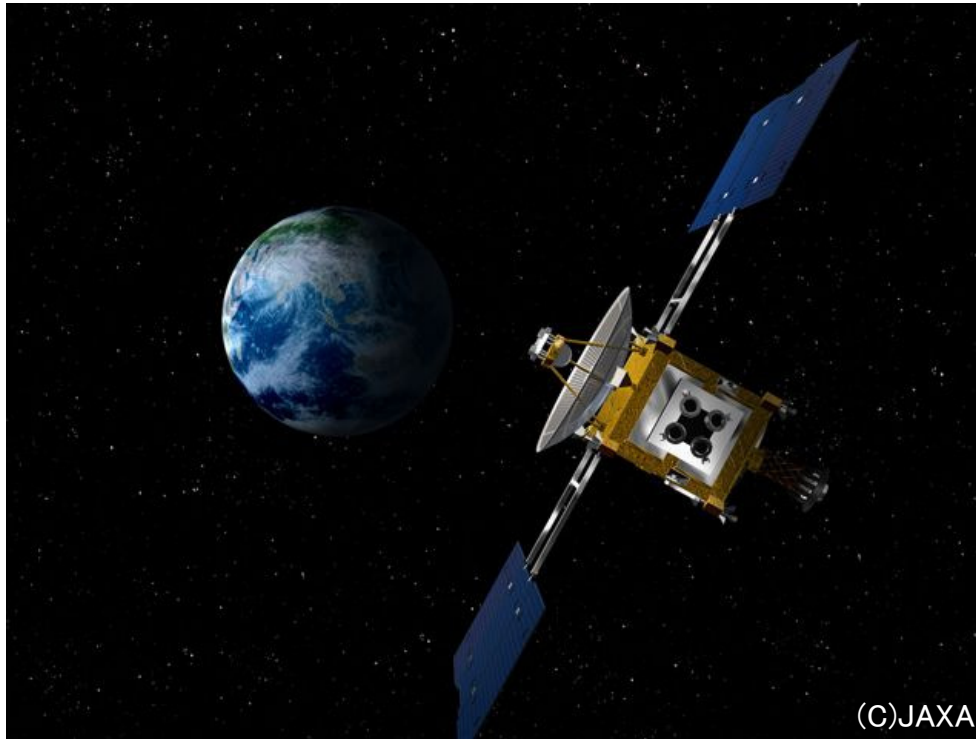
Size of “Hayabusa” Spacecraft

Mass: 510kg@Launch
